When the material fails: Failure analysis at HTV

Autors: Dr. Thorsten Leist, Dr. Wiebke Valouch
HTV Conservation GmbH, Bensheim, Germany, 2023

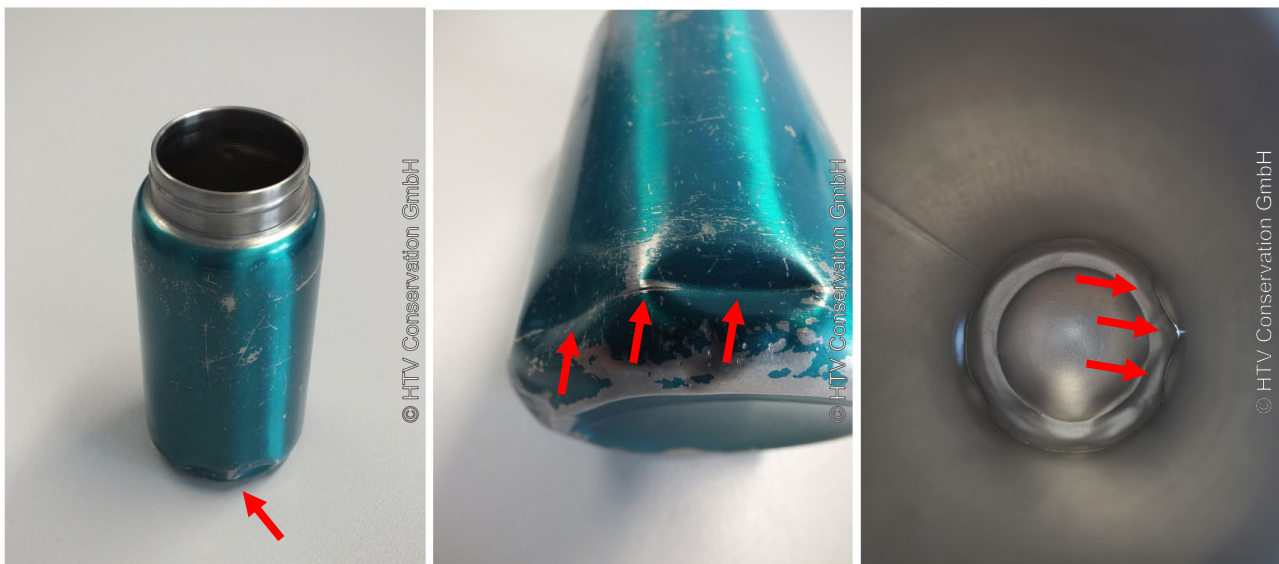
In the investigated case, a mechanical deformation of a bottle has led to tearing of the material. As a result, the function of the product is no longer given and the bottle is leaking.

Abbildung 1: Defective product after mechanical impact (damage area, red)

The failure pattern clearly shows a preferred area in which the deformation propagates (cf. Figure 1). A detailed examination showed that the material failure and the preferred direction of deformation follow a hidden weld seam. Based on this finding the further procedure was aligned and the corresponding analysis methods were selected.

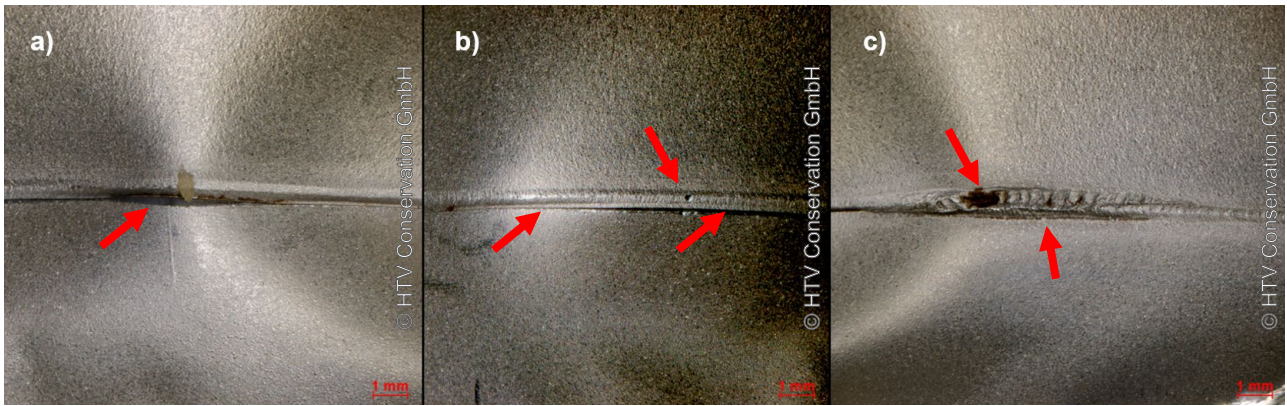
The optical microscopy shows that the execution of the weld seam appears to be defective in several places (cf. Figure 2). The weld showed hard defined areas, both at the location of the fracture and at other locations,

indicating the presence of weld undercuts. Areas of significant weld overlap, pores within the weld and traces of corrosion were also documented.

Figure 2: Light microscopy of the weld seam with damage area a), weld seam with pore and undercut b) and overlap with corrosion trace c) – conspicuous features are marked in red

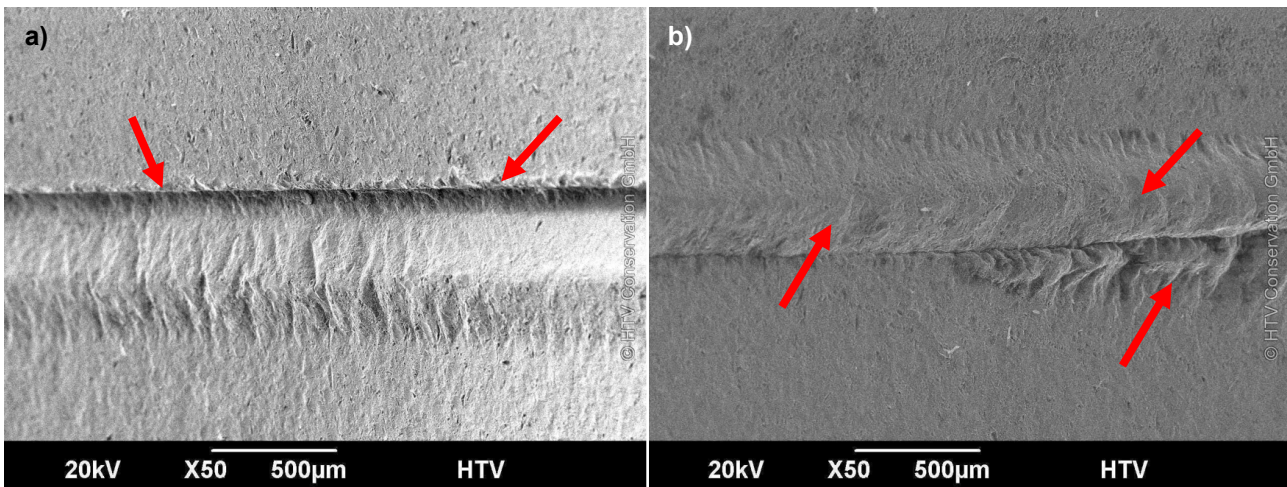
An examination under the scanning electron microscope underlined the findings (cf. Figure 3 f.) and showed a clear undercut as well as a weld overlap. A typical dendritic structure was found within the weld. The fracture surface, which makes the fracture mechanism accessible, was also microscoped in detail (cf. Figure 5). This shows a fracture surface whose structure indicates a ductile fracture. Thus, failure of the weld due to force alone is unlikely. Rather, the geometry of the weld was a weak point that led to the fracture under load.

Figure 3: Scanning electron micrograph of the weld seam with undercut a) and overlap b) (conspicuities are marked red)

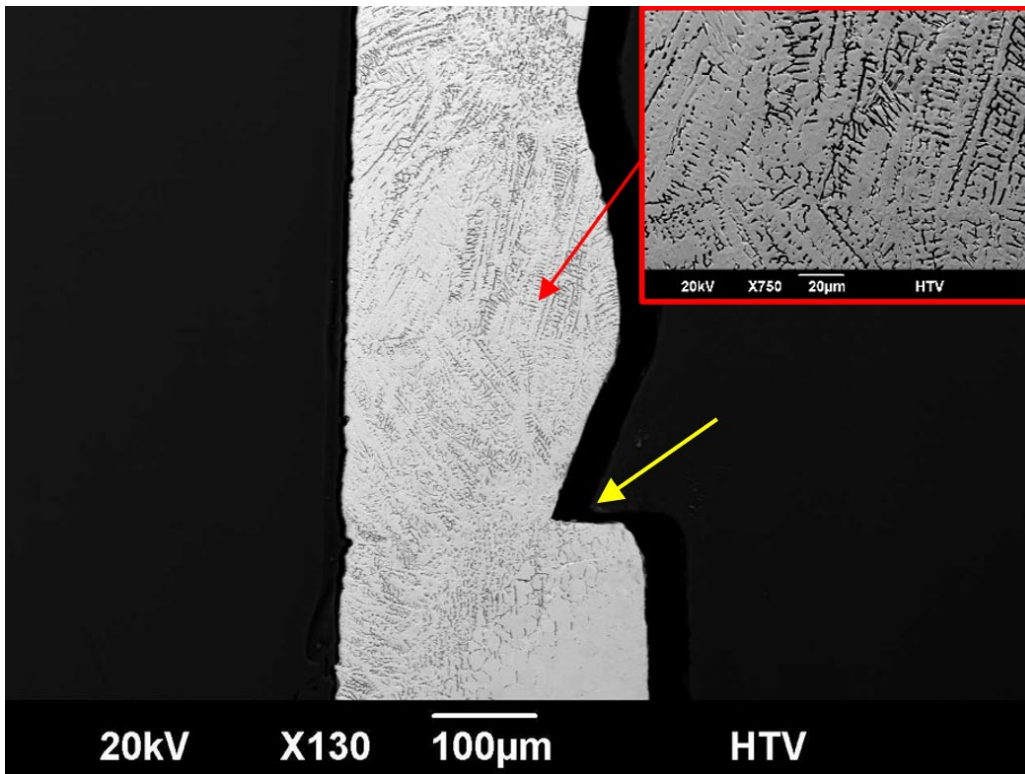
Figure 4: Weld seam in micrograph with undercut (yellow) and dendritic structure (red)

is therefore the only possible cause of damage. The penetration notch found along the weld seam exceeds the maximum depth acceptable by DIN EN ISO 5817 and acts with sufficient probability as a crack nucleus in the damage case shown here.

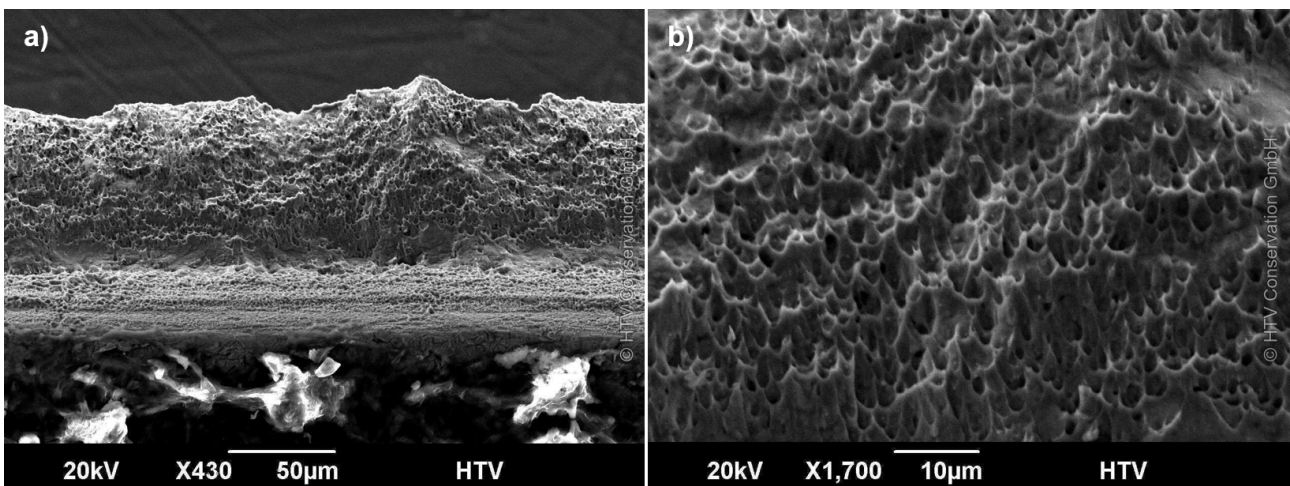
Figure 5: SEM image of the fracture surface with overview a) and detail b)

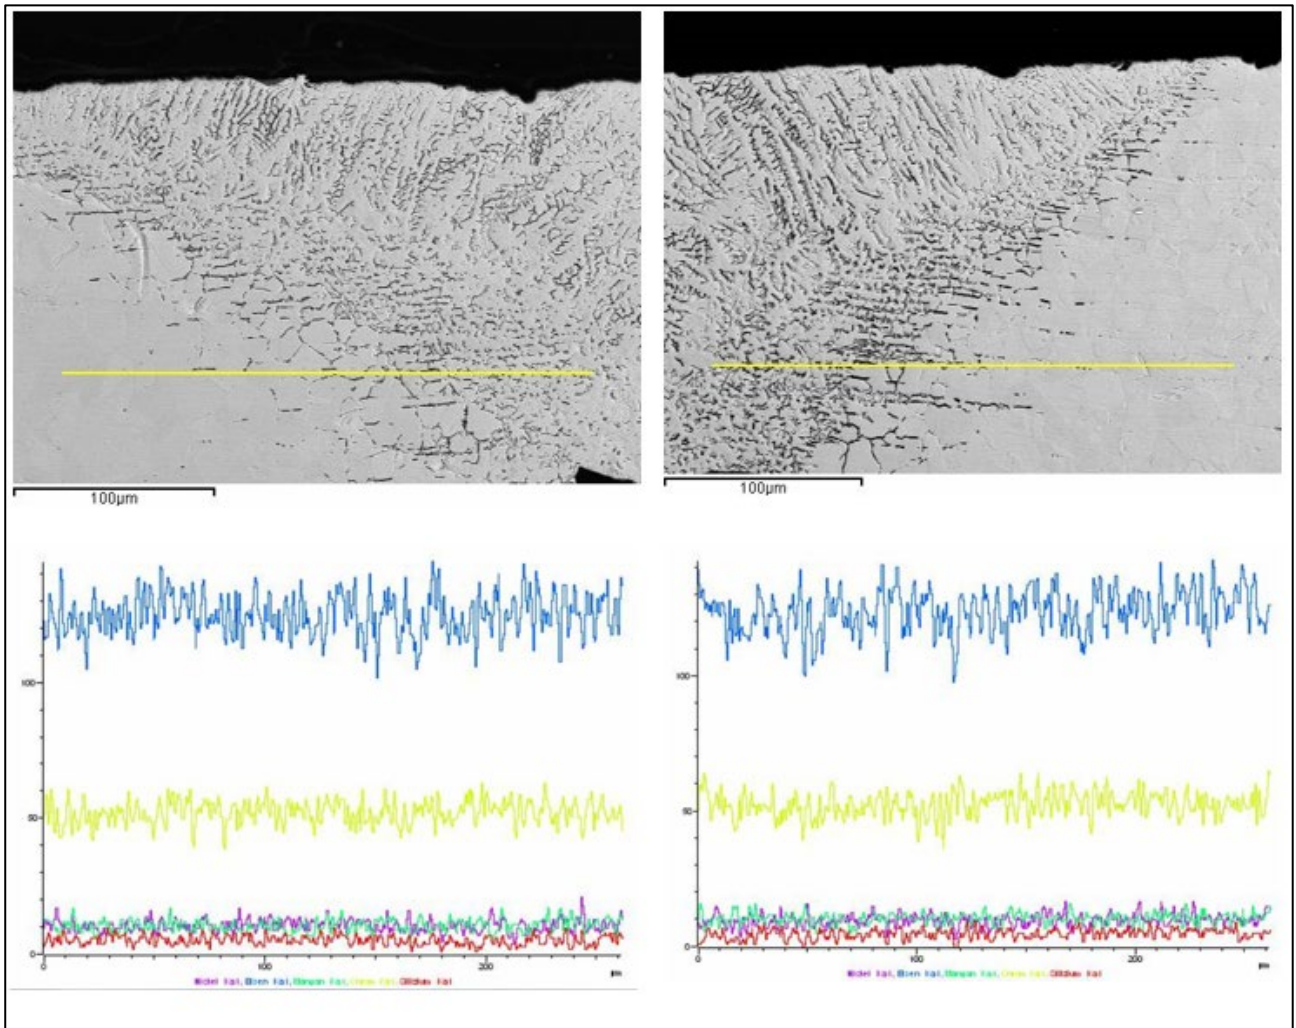
The measurements showed that the material for the weld seam does not have any differences in its elemental composition compared to the workpiece (cf. Figure 6) and thus material differences can be ruled out as a cause of failure. The hardness of the weld seam is also not considered to be noticeably different from the rest of the material (cf. Figure 7) and therefore cannot be considered as the cause of the failure. The weld geometry

Figure 6: EDX line measurement on both sides of the weld. No changes can be detected along any line.

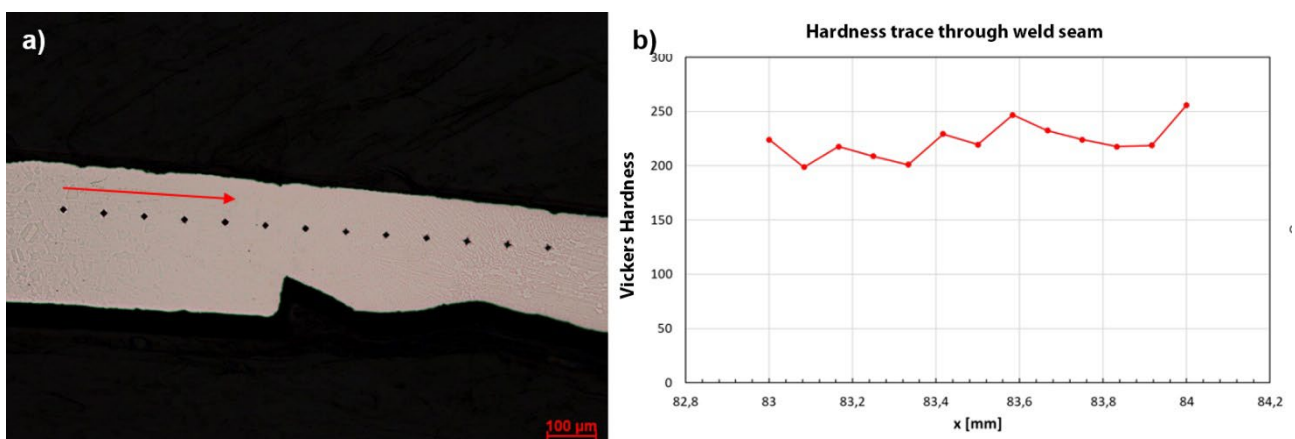
Figure 7: Impressions from nanoindentation along the weld a) and corresponding hardness values b)
