# When the material fails: Failure analysis at ALTER | HTV

## 1. Description of the error pattern

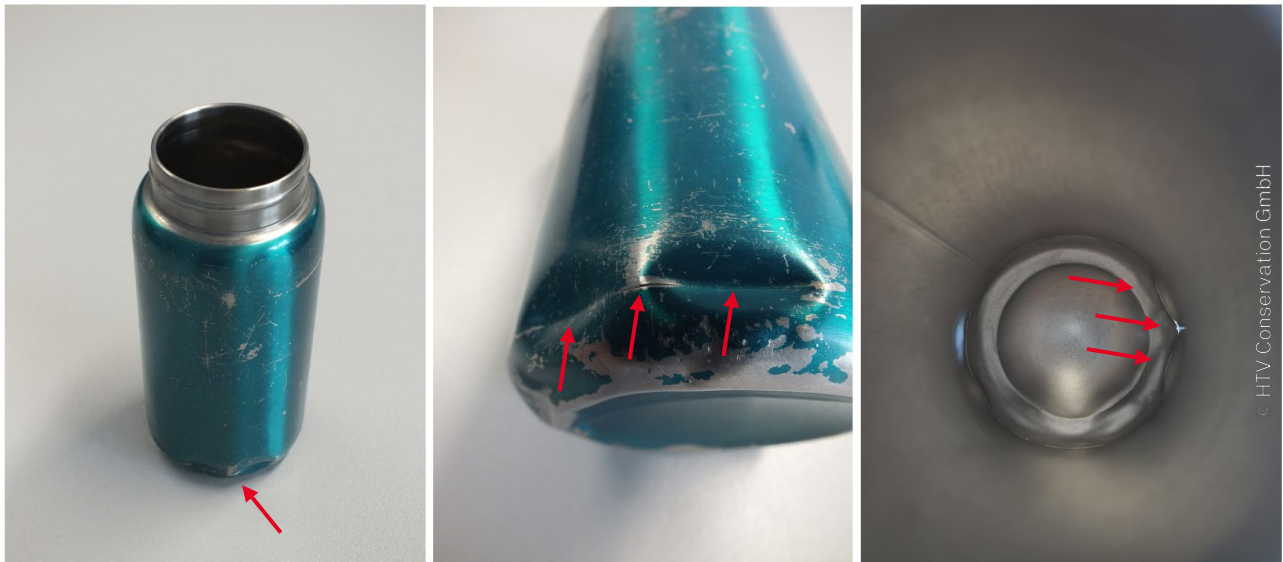
Figure 1: Defective product after mechanical impact (damage area, red)

The failure pattern clearly shows a preferred area in which the deformation propagates (cf. Figure 1). A detailed examination showed that the material failure and the preferred direction of deformation follow a hidden weld seam. Based on this finding the further procedure was aligned and the corresponding analysis methods were selected

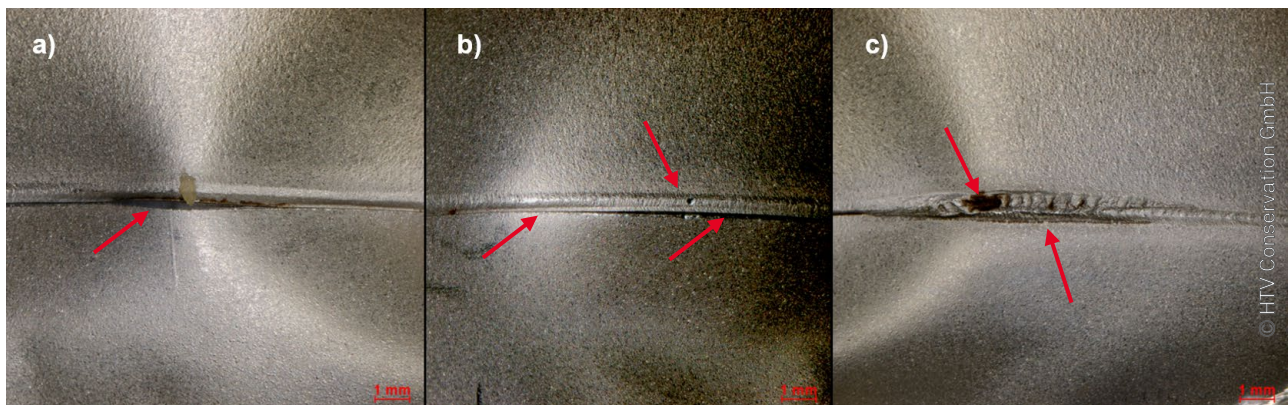
The optical microscopy shows that the execution of the weld seam appears to be defective in several places (cf. Figure 2). The weld showed hard defined areas, both at the location of the fracture and at other locations, indicating the presence of weld undercuts. Areas of significant weld overlap, pores within the weld and traces of corrosion were also documented.

Figure 2: Light microscopy of the weld seam with damage area a), weld seam with pore and undercut b) and overlap with corrosion trace c) – conspicuous features are marked in red

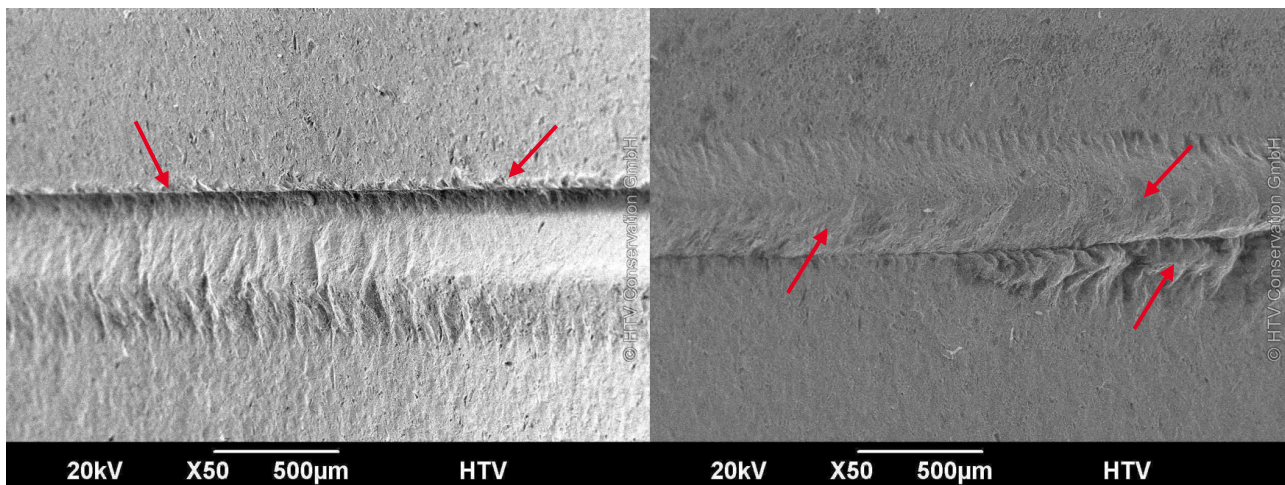
An examination under the scanning electron microscope underlined the findings (cf. Figure 3 f.) and showed a clear undercut as well as a weld overlap. A typical dendritic structure was found within the weld. The fracture surface, which makes the fracture mechanism accessible, was also microscoped in detail (cf. Figure 5). This shows a fracture surface whose structure indicates a ductile fracture. Thus, failure of the weld due to force alone is unlikely. Rather, the geometry of the weld was a weak point that led to the fracture under load.

Figure 3: Scanning electron micrograph of the weld seam with undercut a) and overlap b) (conspicuities are marked red)

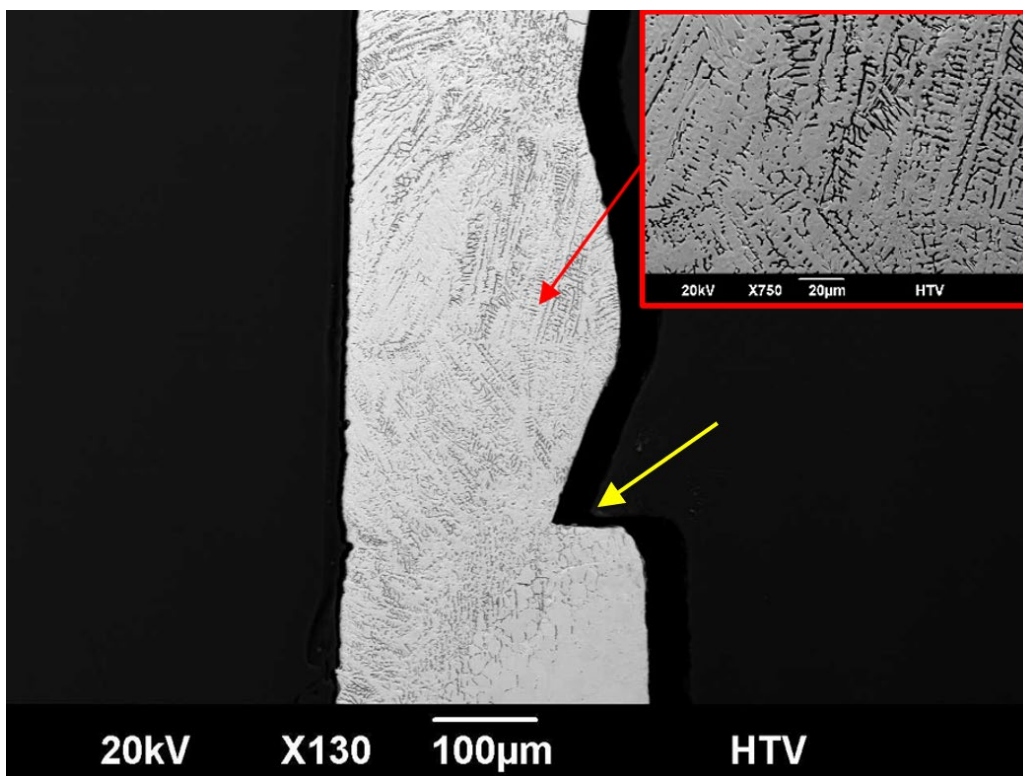
Figure 4: Weld seam in micrograph with undercut (yellow) and dendritic structure (red)

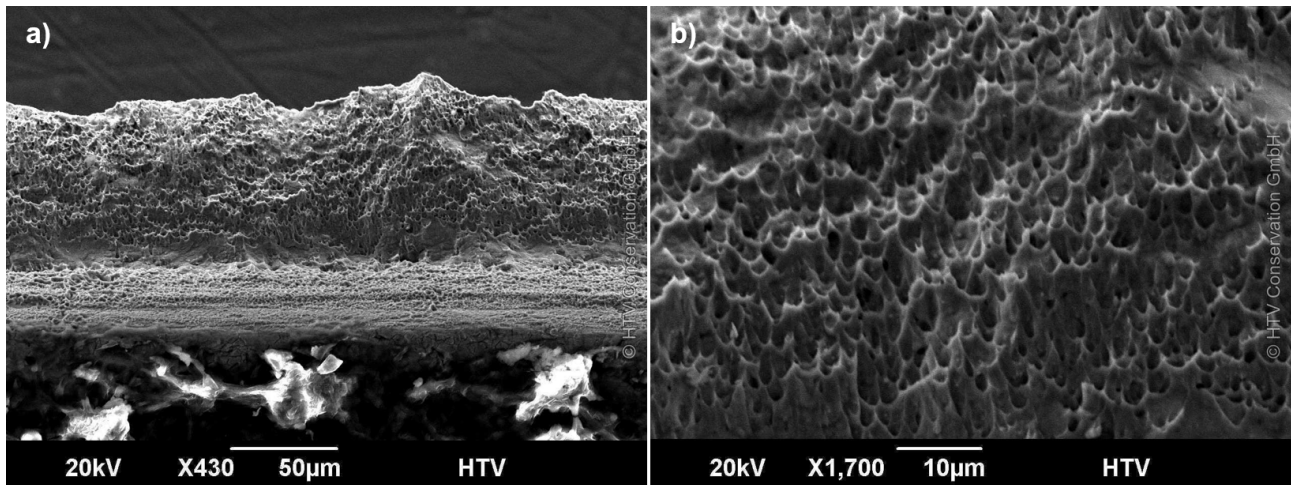
Figure 5: SEM image of the fracture surface with overview a) and detail b)

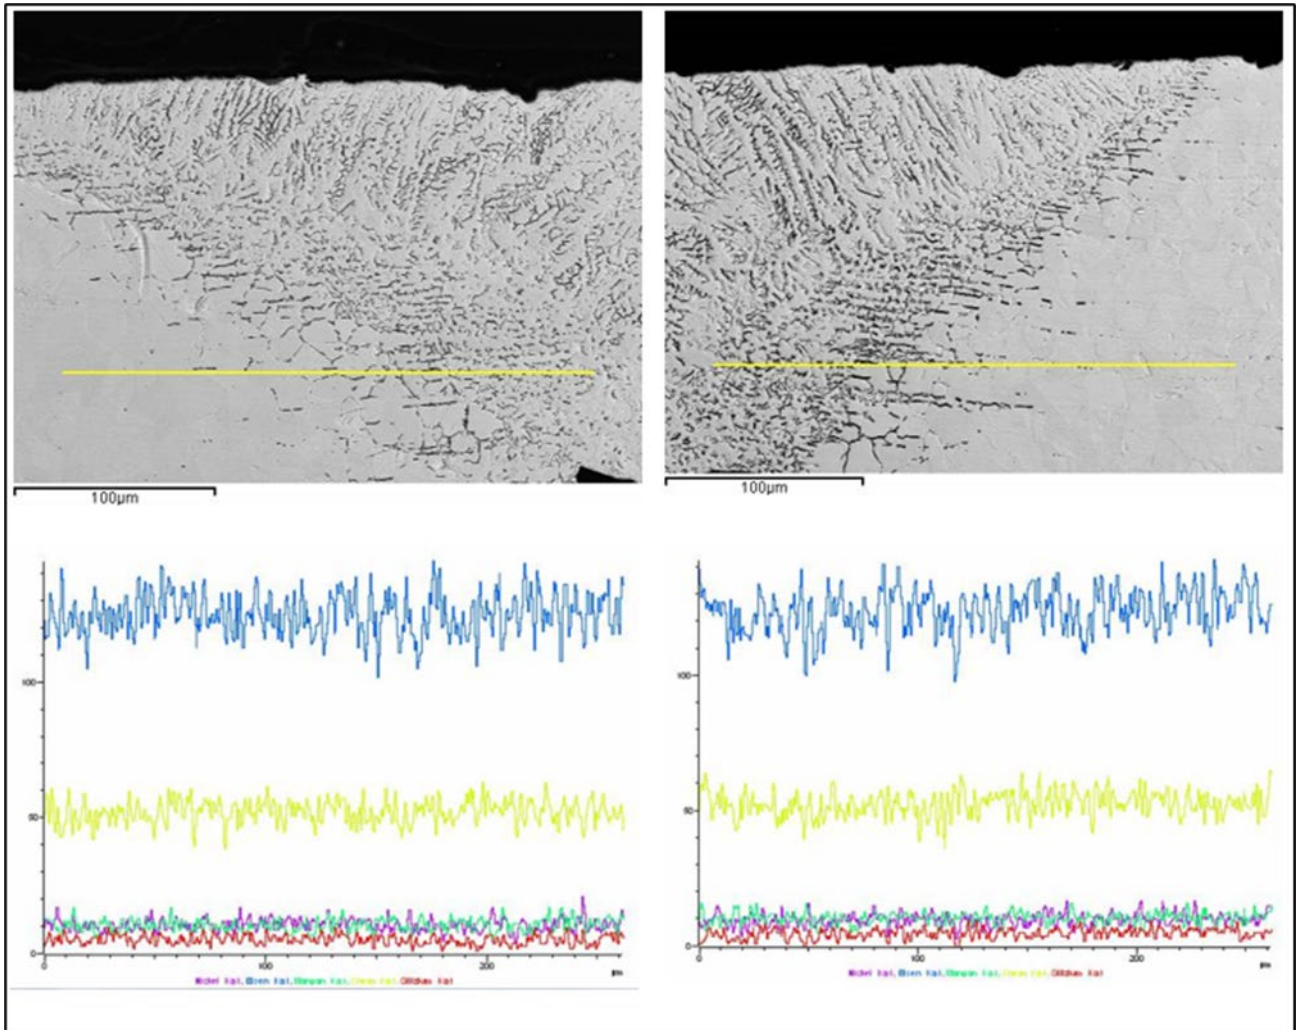
The measurements showed that the material for the weld seam does not have any differences in its elemental composition compared to the workpiece (cf. Figure 6) and thus material differences can be ruled out as a cause of failure. The hardness of the weld seam is also not considered to be noticeably different from the rest of the material (cf. Figure 7) and therefore cannot be considered as the cause of the failure. The weld geometry is therefore the only possible cause of damage. The penetration notch found along the weld seam exceeds the maximum depth acceptable by DIN EN ISO 5817 and acts with sufficient probability as a crack nucleus in the damage case shown here.

Figure 6: EDX line measurement on both sides of the weld. No changes can be detected along any line.

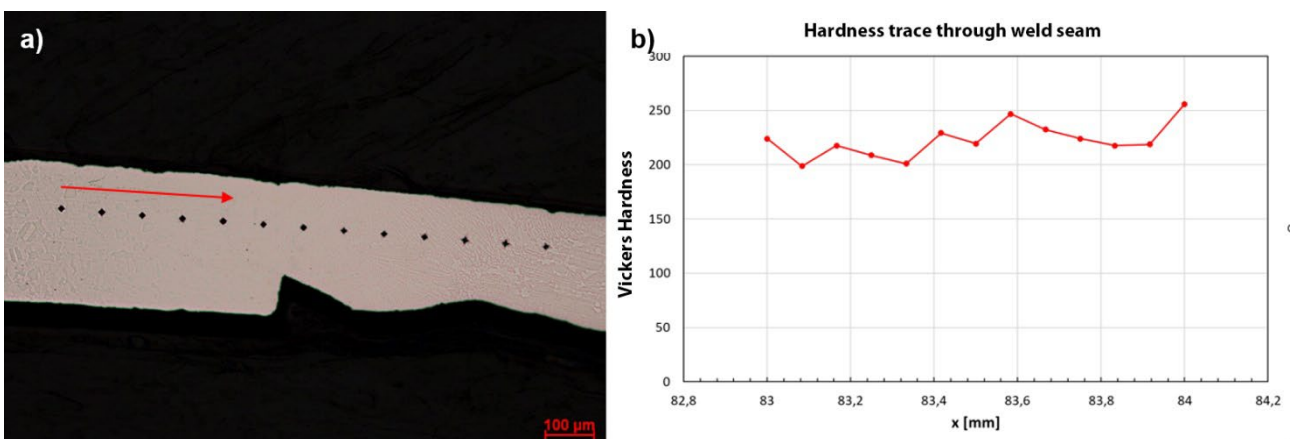
Figure 7: Impressions from nanoindentation along the weld a) and corresponding hardness values b)
